**MARYLAND HISTORICAL TRUST
DETERMINATION OF ELIGIBILITY FORM**

Property Name: 816 Edgewood Road Inventory Number: HA-2071
Address: 816 Edgewood Road MD 755 Historic district: yes ☒ no
City: Edgewood Zip Code: 21040 County: Harford
USGS Quadrangle(s): Edgewood
Property Owner: Michele Ross Tax Account ID Number: 01-014730
Tax Map Parcel Number(s): 685 Tax Map Number: 65
Project: MD 755: MD 24 to Willoughby Beach Road Agency: State Highway Administration
Agency Prepared By: State Highway Administration
Preparer's Name: Melissa Hess Date Prepared: 02/21/2006
Documentation is presented in: _____
Preparer's Eligibility Recommendation: _____ Eligibility recommended ☒ Eligibility not recommended
Criteria: A B C D Considerations: A B C D E F G
Complete if the property is a contributing or non-contributing resource to a NR district/property:
Name of the District/Property: _____
Inventory Number: _____ Eligible: yes Listed: yes
to visit by MHT Staff yes ☒ no Name: _____ Date: _____

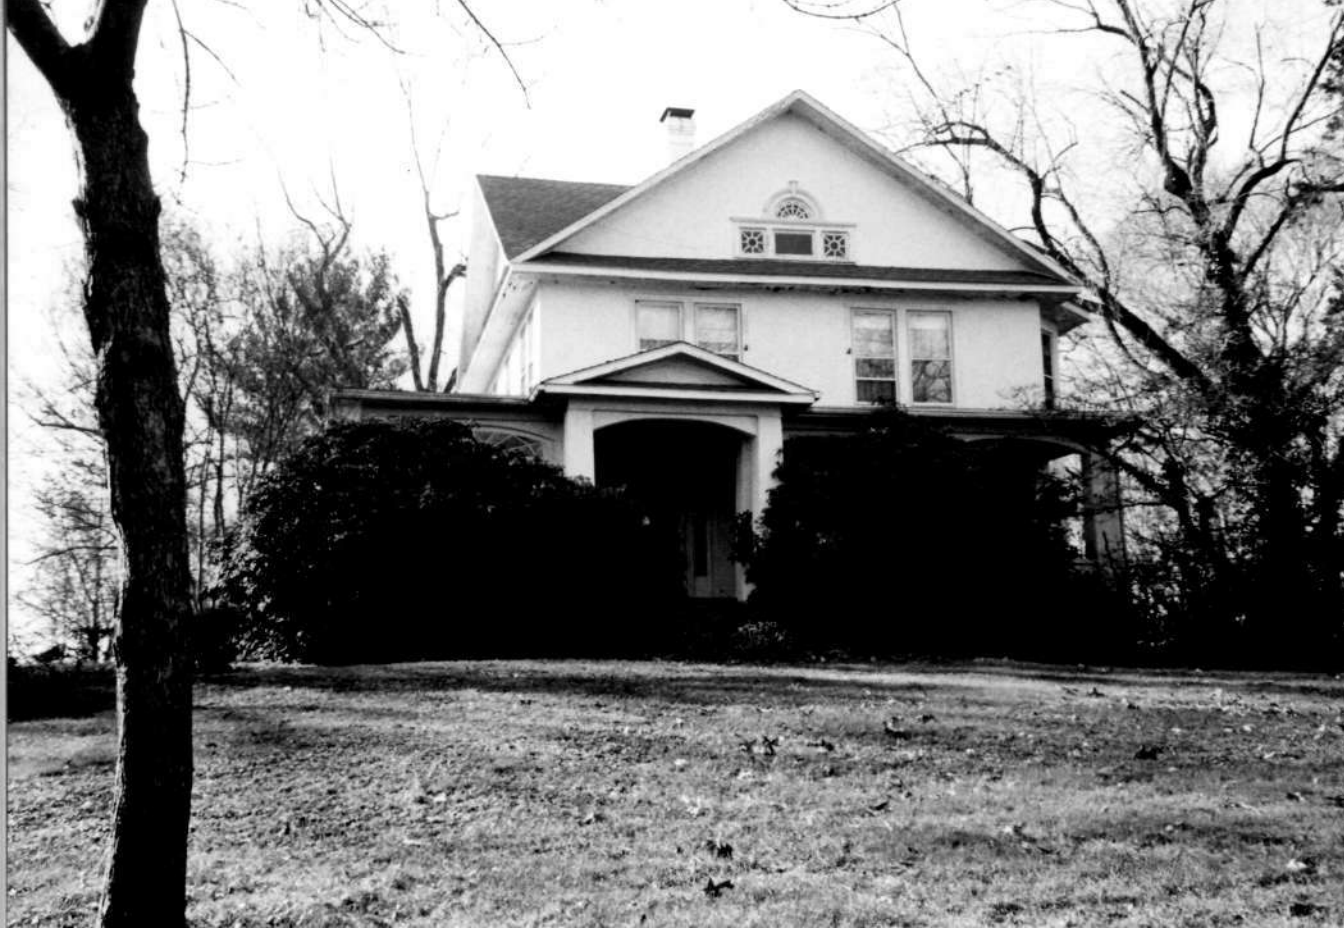
East elevation, View West
Photo 1 of 10

The front façade, or east elevation, features a front entrance with an original elliptical fanlight and side lights and modern glass panel door with an aluminum screen door. Two second-story windows on this façade are modern replacements, but the attic light is a modified Palladian window with uniquely patterned muntins and wood surrounds with dentil molding. There is a full-width porch with square columns on the front façade that wraps to the south elevation, which is open to the north of the front entrance and enclosed to the south of the entrance. The enclosed area feature sets of four nine-pane windows topped with elliptical fanlights.

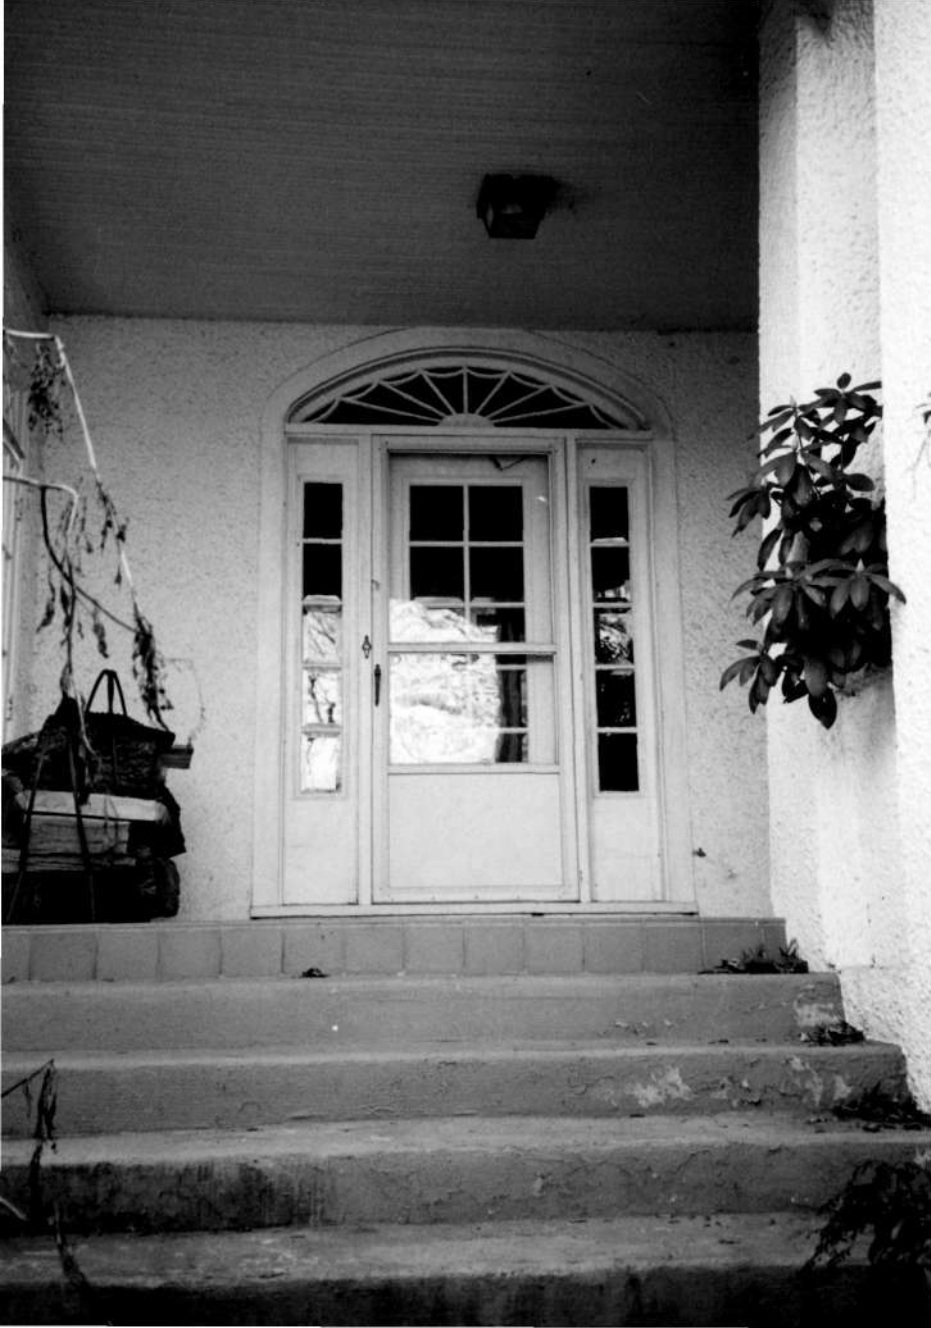
East elevation, front entrance
Photo 2 of 10

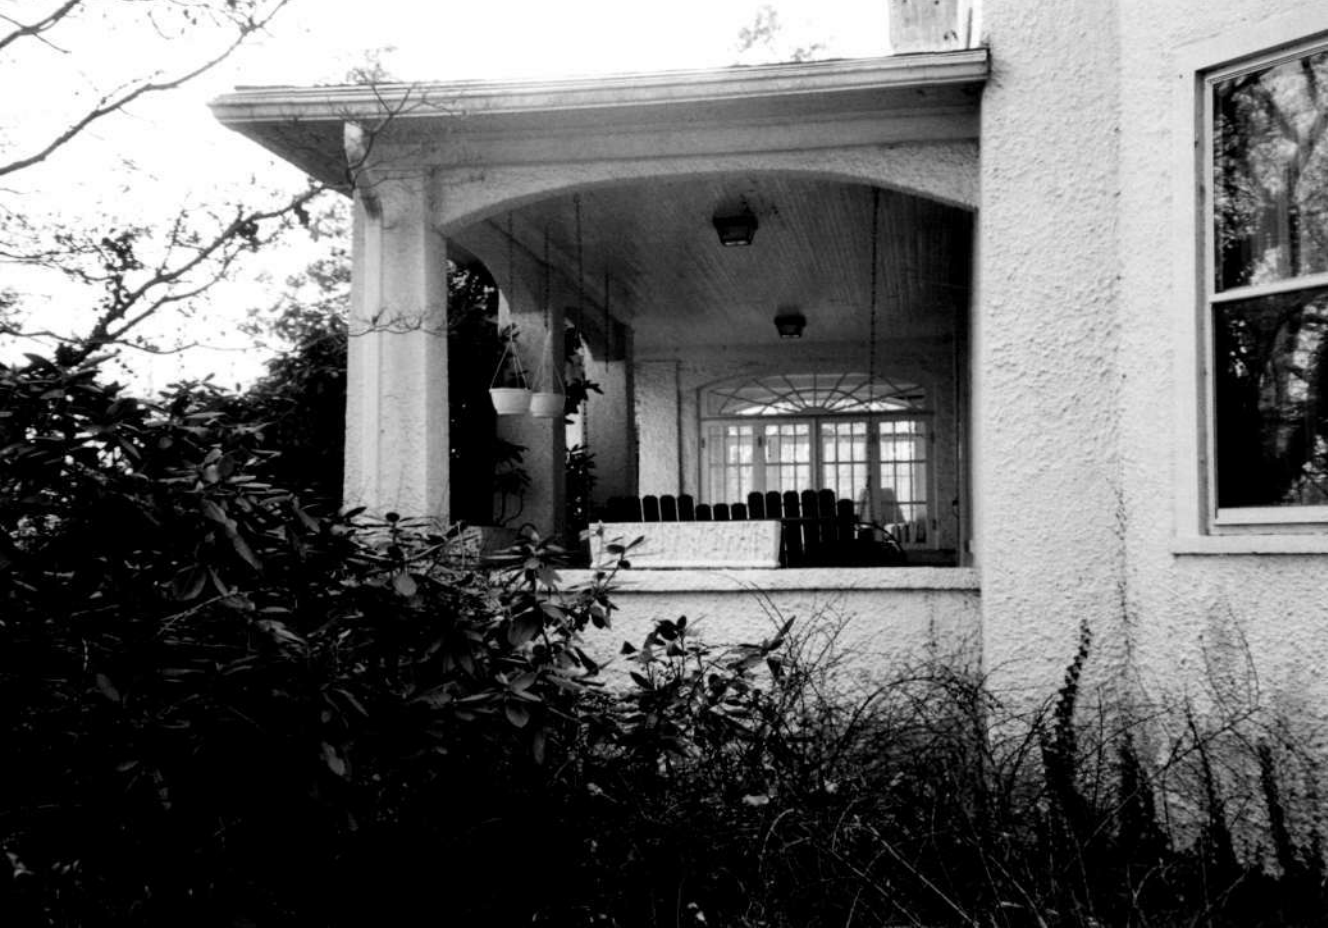
Front porch, View South
Photo 3 of 10

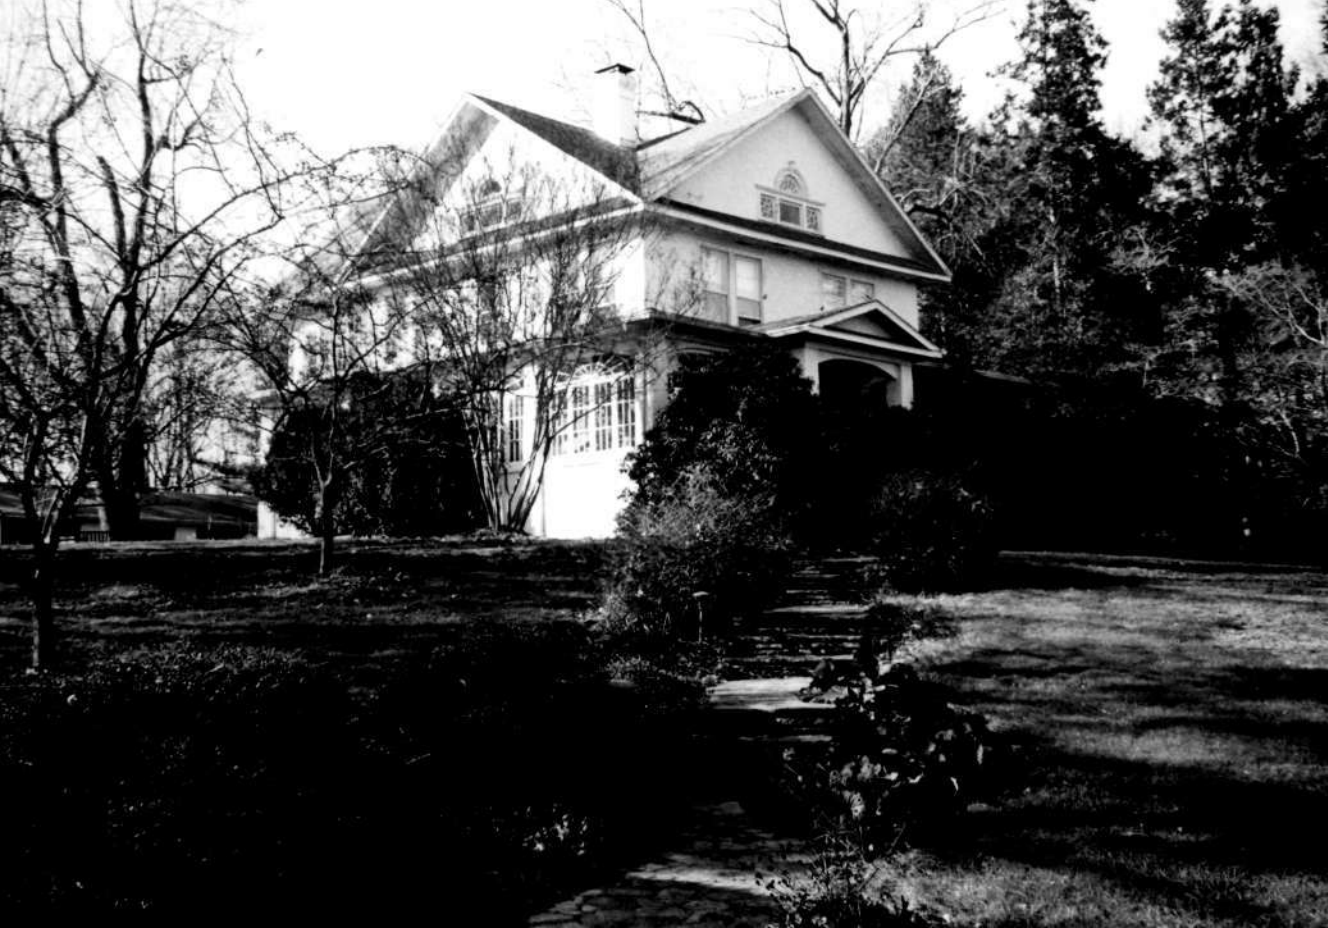
South and east elevations, View Northwest
Photo 4 of 10

The first story of the south elevation feature a row of the above-described windows on the enclosed porch area and a pair of one-over-one double hung sashes. The second story has five one-over-one double hung sashes and a pair of modern double casement

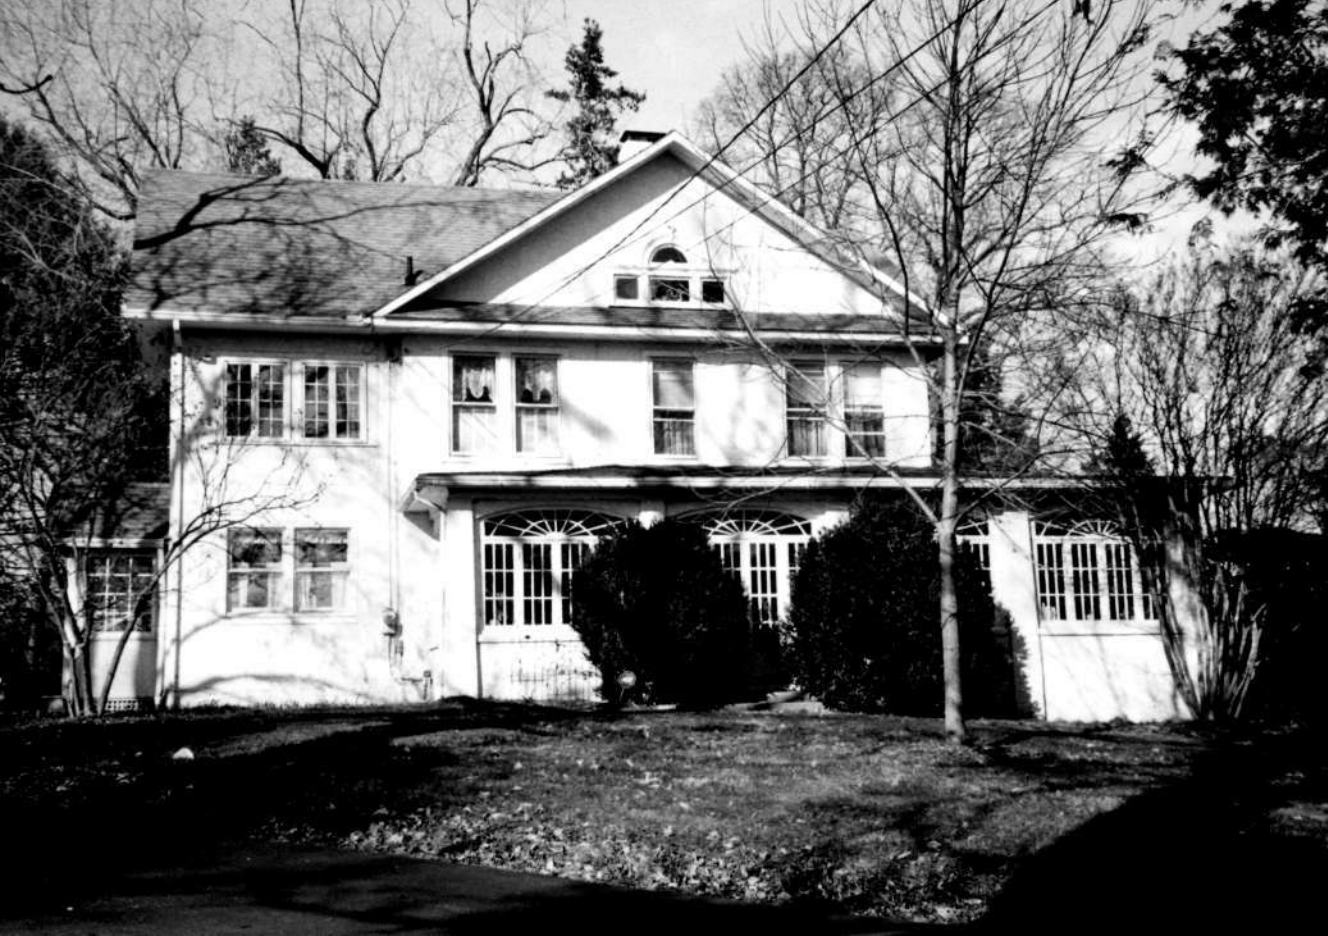
South Elevation, View North
Photo 5 of 10

windows with fake muntins. The attic light is similar to the one of the front façade, but with solid panes.

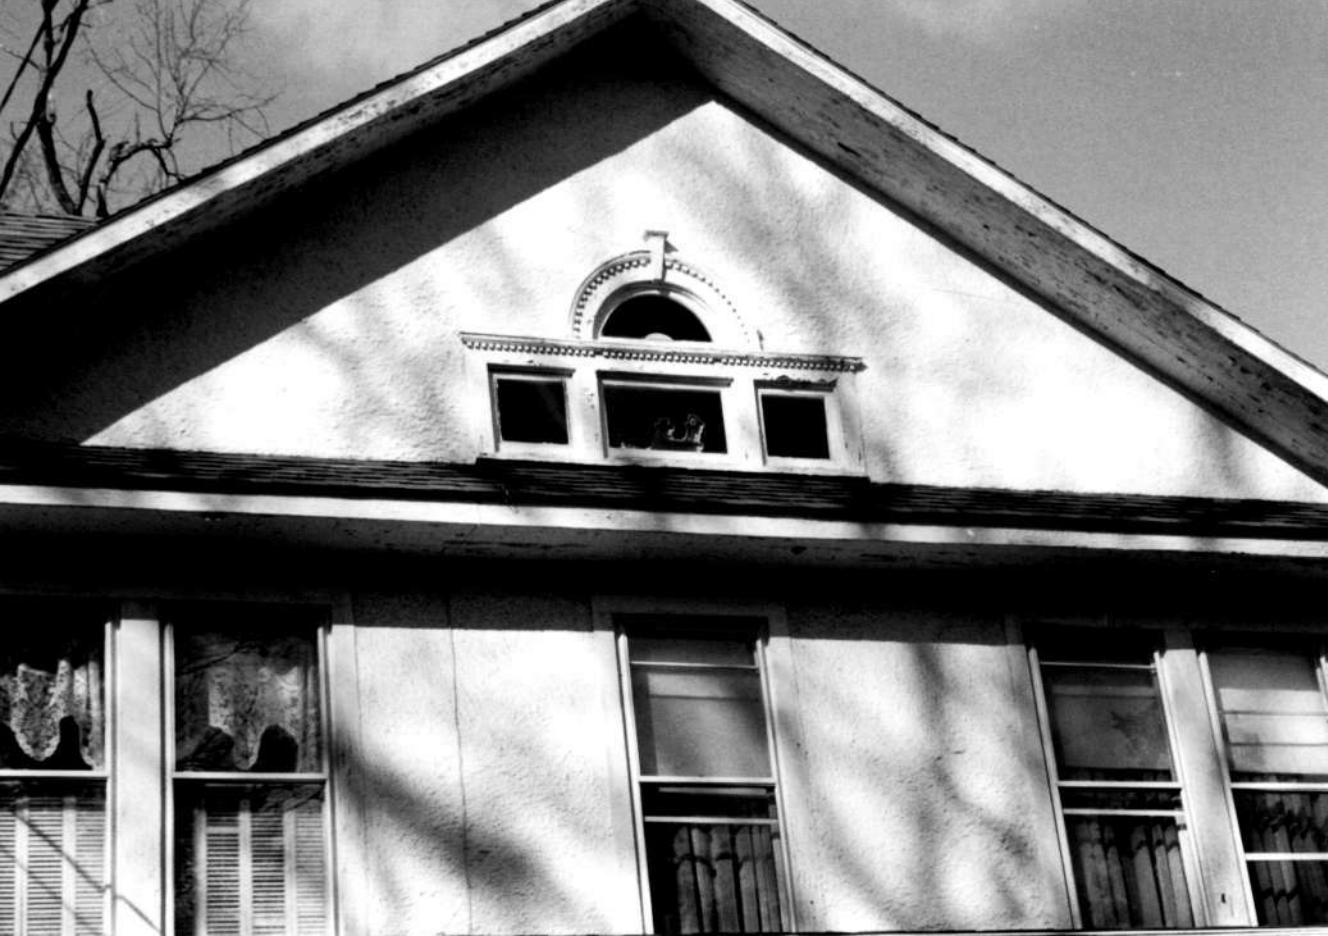
Photo 6 of 10

South elevation, gable end detail

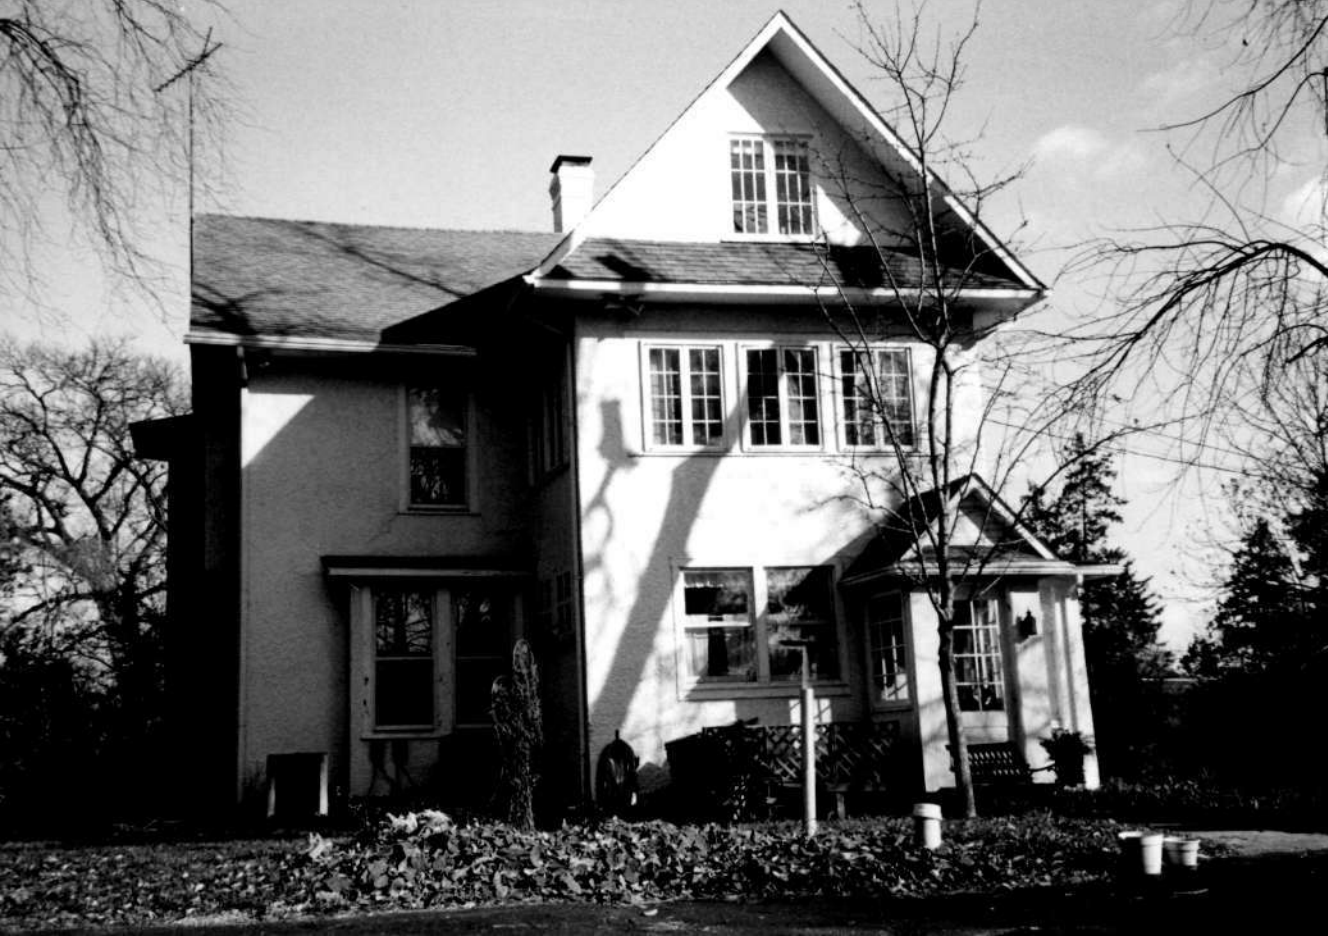
Photo 7 of 10

West Elevation, View East

The west elevation has both modern casement windows and one-over-one double hung sashes. The attic level features an original pair of nine-pane casement windows. This façade has a projecting rear entrance with a gable roof and a shallow projecting bay with a shed roof on the first story.

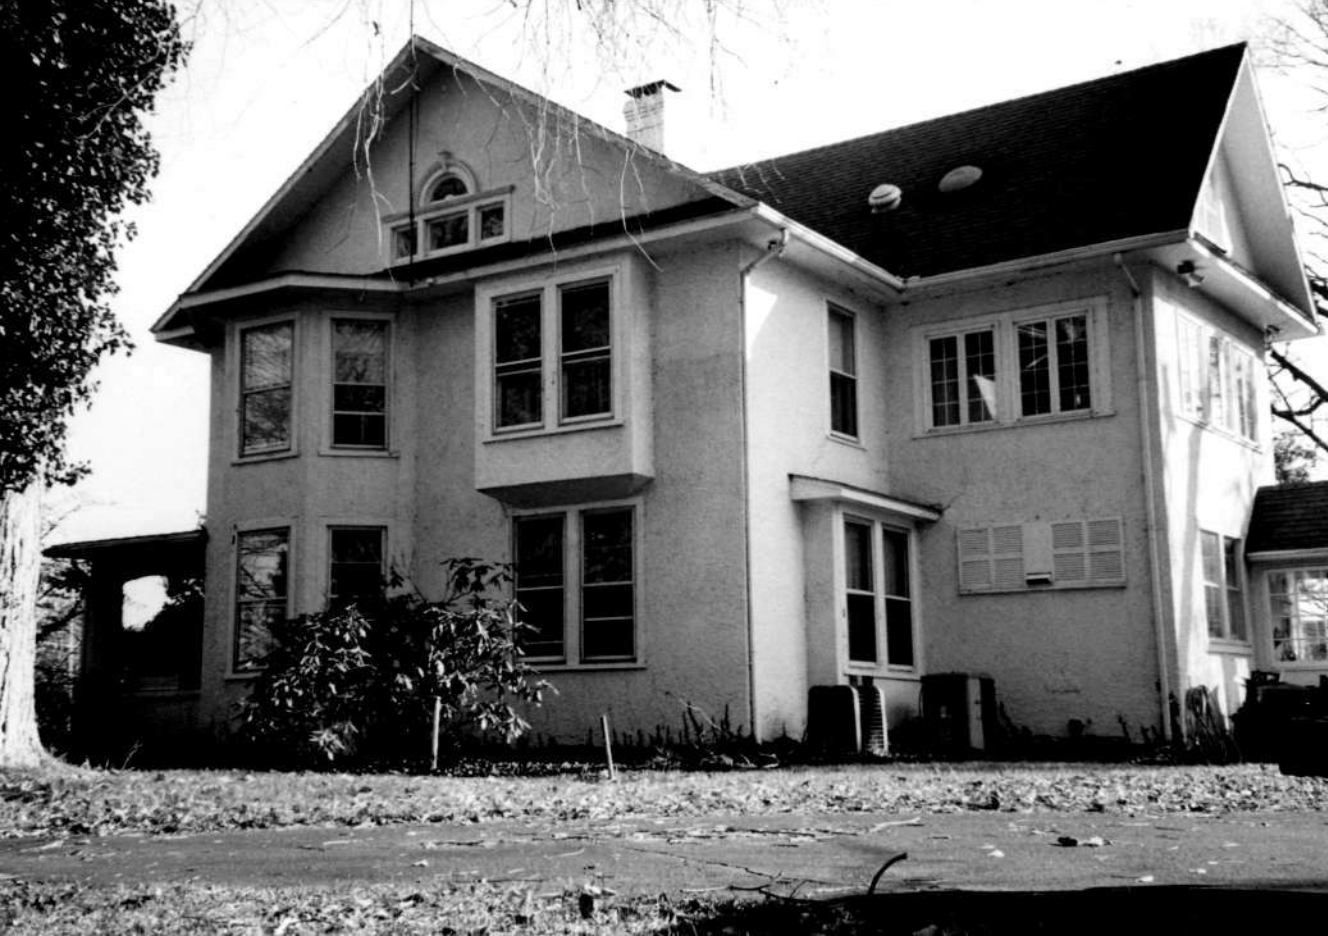
North elevation, View Southeast
Photo 8 of 10

The north elevation features one-over-one double hung sash windows and an attic light identical to the one on the south elevation. This elevation has a two-story polygonal bay, as well as a shallow projecting bay on the second story.

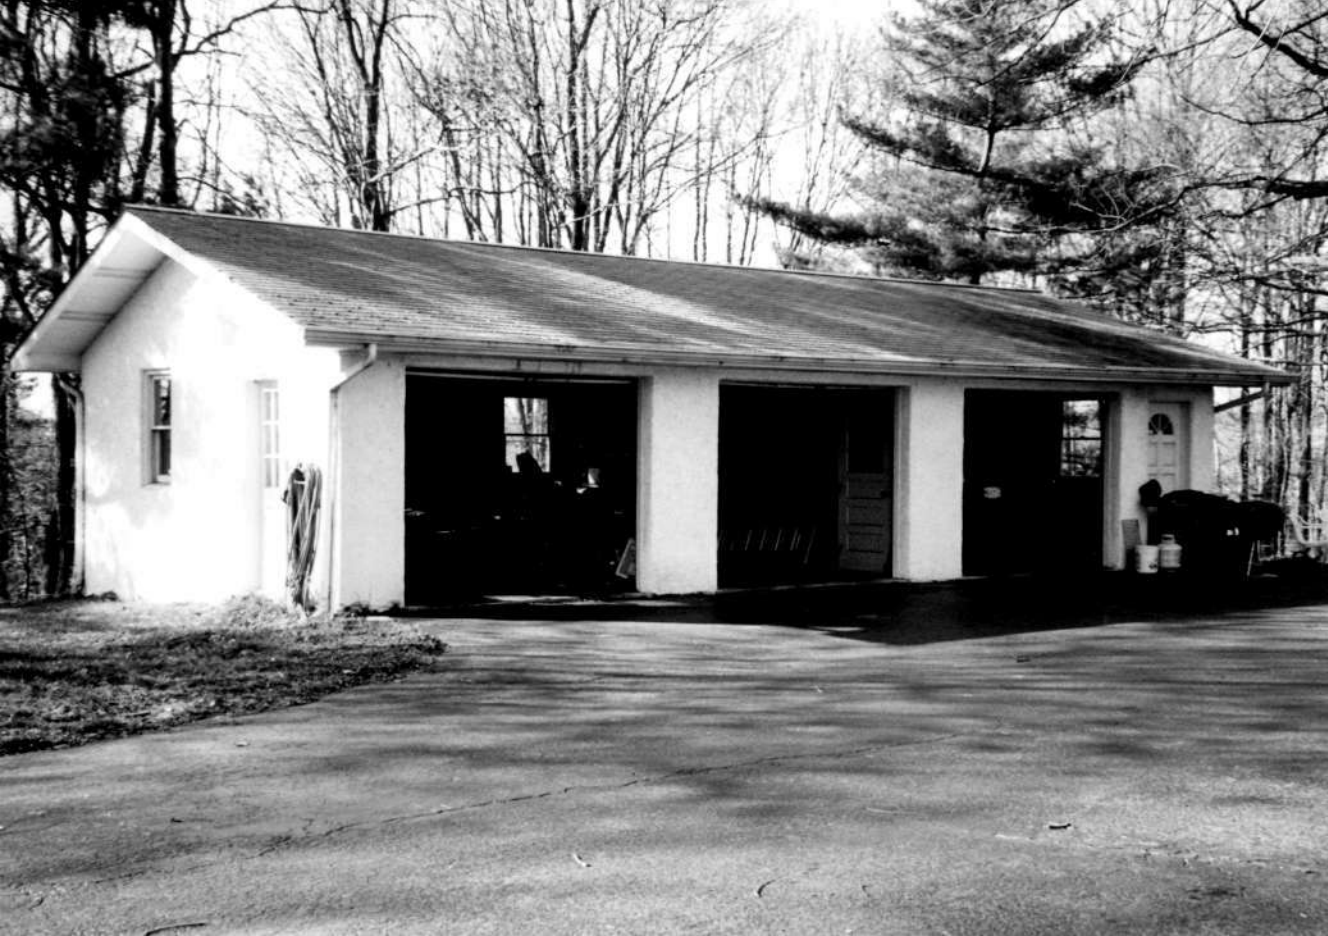
Photo 9 of 10

Garage, View Northeast

The grounds contain several mature trees and a line of trees across the front of the property that provides a buffer from the roadway. A circular macadam drive leads to the rear of the house. There is a three-car garage to the west of the dwelling and a one-story guest house to the southwest of the dwelling.

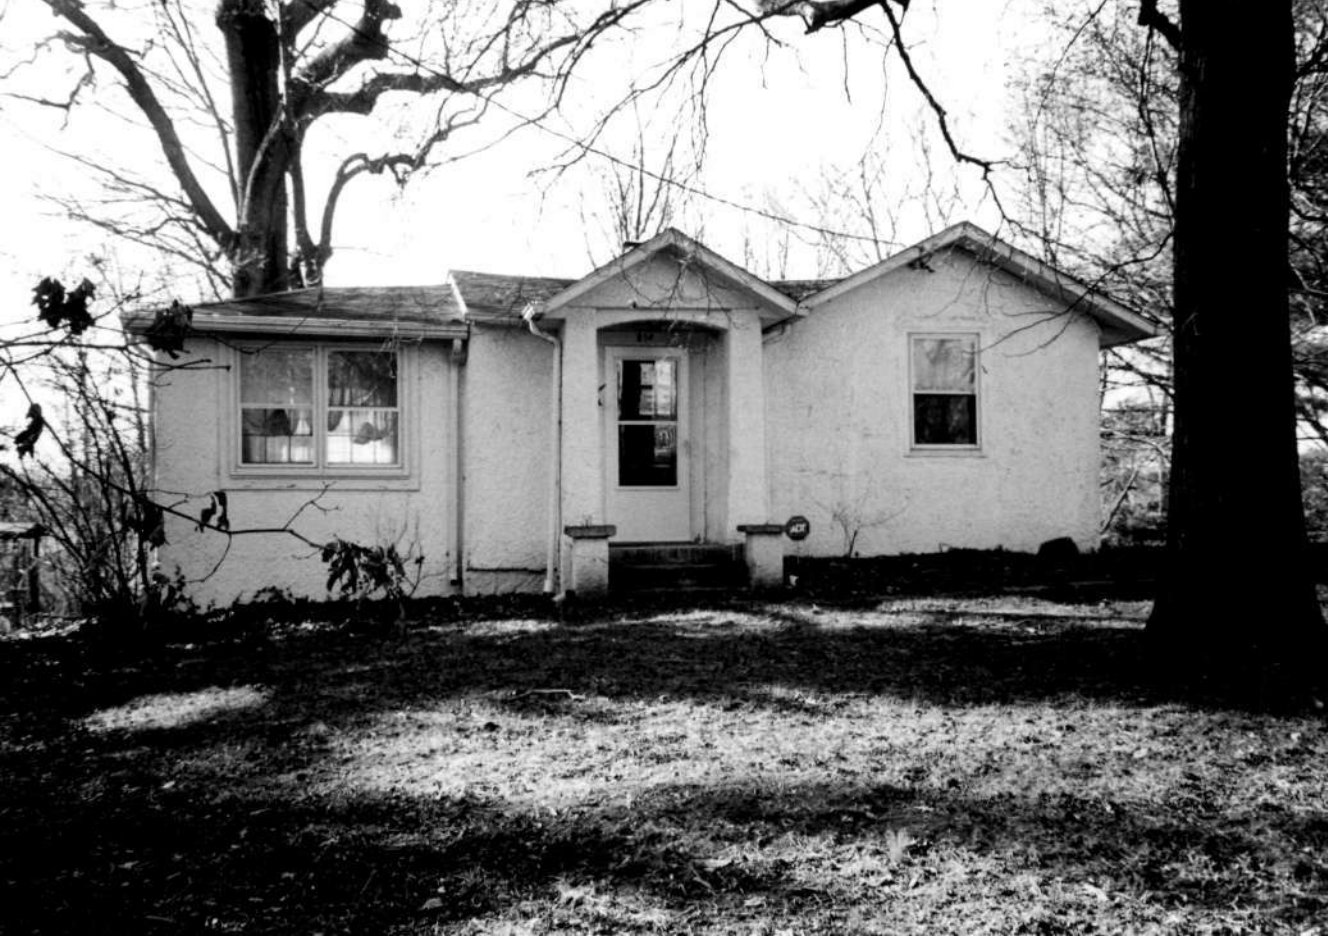
Photo 10 of 10

Guest House, View South
